# Supercombinata BASIC for the reparation of an excavator bucket

The Supercombinata BASIC is Elsa's new answer for the earthmoving sector. In this case study the boring machine was used on-site to repair the bucket of a JCB back excavator.

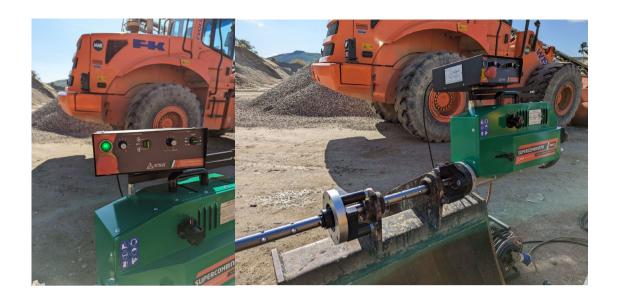
Through an unidirectional DC controller, the electronic control unit controls the drives of the machine by regulating the speed and direction of rotation, and that of the feed of the machine. Thanks to the few and intuitively recognizable operating switches, the user was able to adjust the various parameters quickly and easily.
