# REPARATION OF AN EXCAVATOR BUCKET

**SUPERCOMBINATA<sup>®</sup>  
BASIC**

The Supercombinata BASIC is Elsa's new answer for the earthmoving sector. In this case study the boring machine was used on-site to repair the bucket of a JCB back excavator.

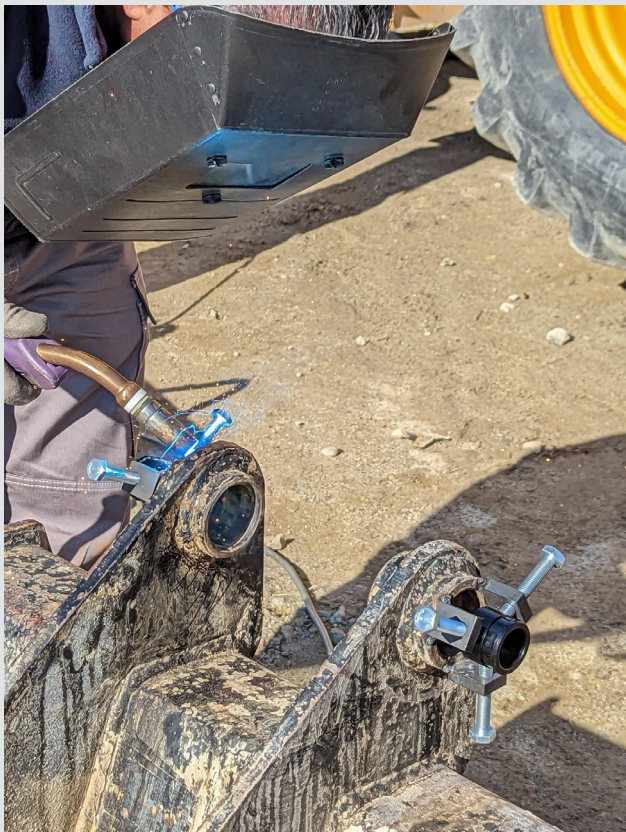
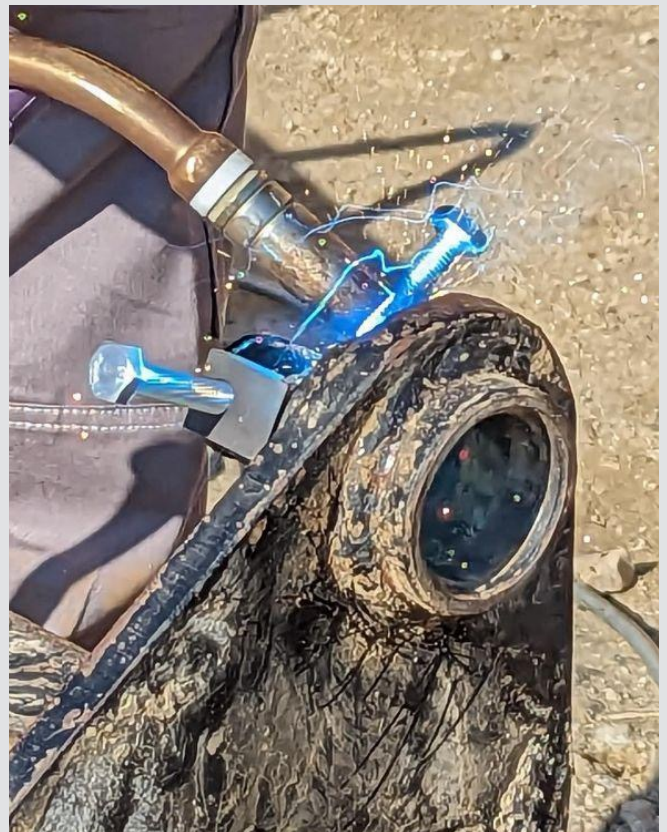
## CENTERING OF THE BORING BAR

Before starting the welding work, the surface was cleaned. The centering was done in traditional way, by welding the corresponding ELSA centering kit.

It should be emphasized that the welding mode was preferred over other centering types, as working with this centering kit ensures higher precision for further processing.

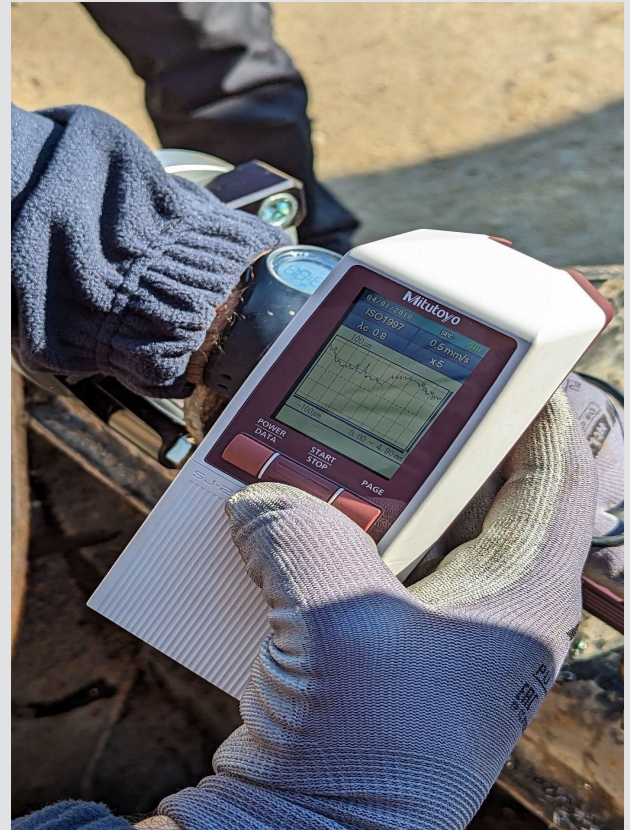
## ACHIEVED RESULTS

At the end of machining, after having completed the repair of the holes, the diameters of the holes and the roughness were measured.

The total time for machining four bushings was approx. 236 minutes (less than 4 hours) and allowed the JCB rear excavator to be repaired in short time. Obviously, the processing time is indicative as it may differ depending on the user's experience.

The final measurements showed a value of 45 mm with H7 tolerance, while the roughness was 3.2  $\mu\text{m}$ .
